# WORK SERIES™ RHA

**COOPER'S SMARTWAY® VERIFIED  
ALL-POSITION REGIONAL AND  
URBAN TIRE FOR LONG MILES TO  
REMOVAL AND FUEL ECONOMY**

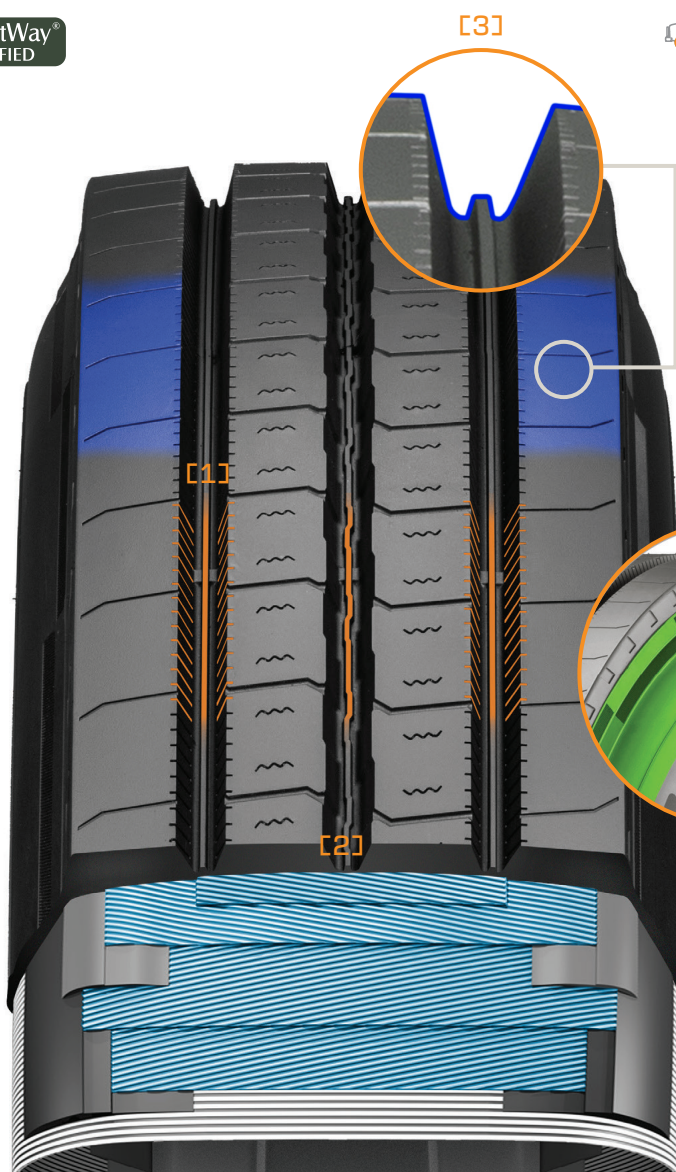
### [1] STONE PROTECTORS AND INNER GROOVE BLADING

Combine to help protect the casing from stone penetration for retreadability

### [2] FULL-WIDTH STEEL BELT CONSTRUCTION

Helps deliver retreadability for low cost of ownership

### [3] ROBUST SOLID SHOULDER WITH DEEP NON-SKID

Helps deliver long miles to removal in high-scrub applications

### [4] SIDEWALL CURB GUARD

Helps protect the sidewall from scrubbing and curb damage often seen in regional applications
